Diaphyseal partial replacement with sleeve coupling for interprosthetic femoral fractures

An 84-year-old patient with right knee and hip prostheses was treated with a plate osteosynthesis following an interprosthetic femoral shaft fracture. Two months post-op, the plate failed. The surgeon, Dr. med. Karl Schmoranzer, chief physician at the Department of Orthopedics and Traumatology at the Martin Luther Hospital in Berlin, ordered a customized component from LINK to provide a strong connection for the prosthesis stems.

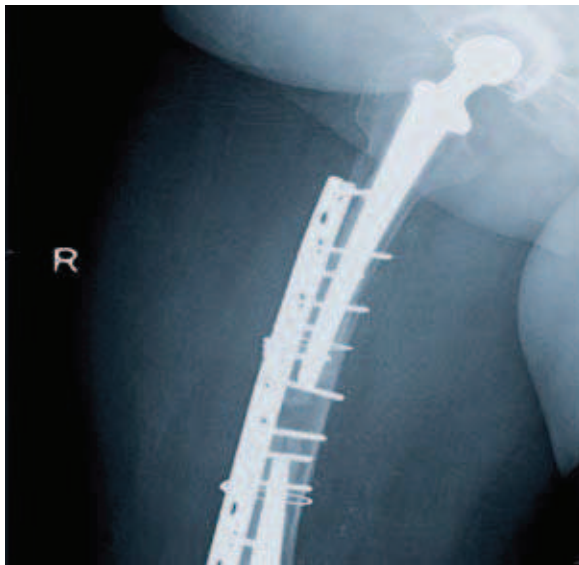
Interprosthetic femoral fracture caused by a fall: Plating of the femur shaft with in-situ LINK® Endo-Model® Knee Prosthesis and LINK® SPII® Hip Prosthesis

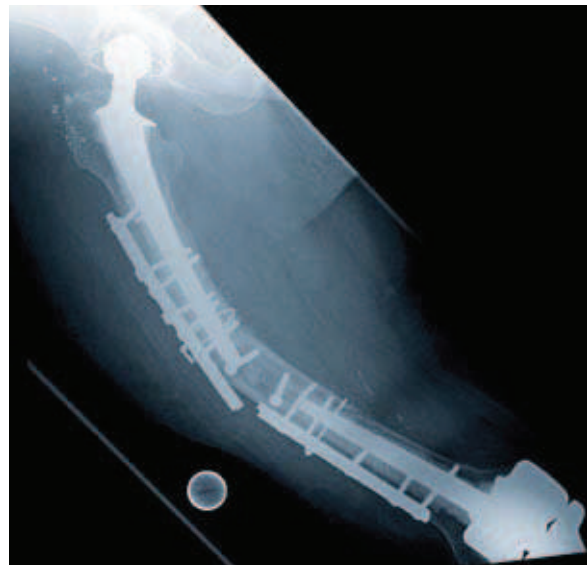
84-year-old female patient with right femoral shaft fracture between LINK SPII® Hip Prosthesis and LINK® Endo-Model® Rotational Knee Prosthesis, sustained due to a fall; treatment with plate osteosynthesis; plate failure with pseudarthrosis of the femoral shaft after two months; patient unable to walk.

Two months after plate osteosynthesis: Fracture of the plate with interprosthetic femoral fracture

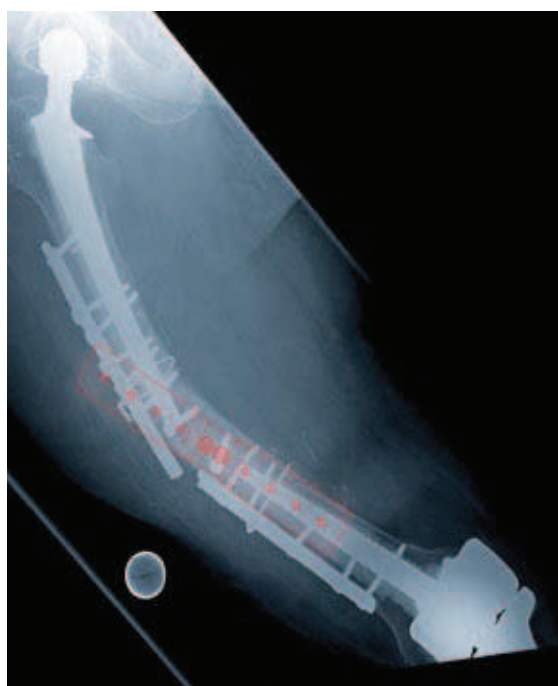
Left: **X-ray image with projected plan:** diaphyseal partial replacement (interposition sleeve)

Middle: **LINK customized solution:** diaphyseal partial replacement with sleeve coupling for hip and knee prosthesis stems, comprising a proximal and a distal component, each with nine stem securing screws and two coupling locking screws, including two plastic stoppers

After assessing the X-ray images, a customized interposition double sleeve was fabricated. The sleeve comprises a proximal and a distal component, each with nine stem securing screws and two coupling locking screws, including two plastic stoppers.

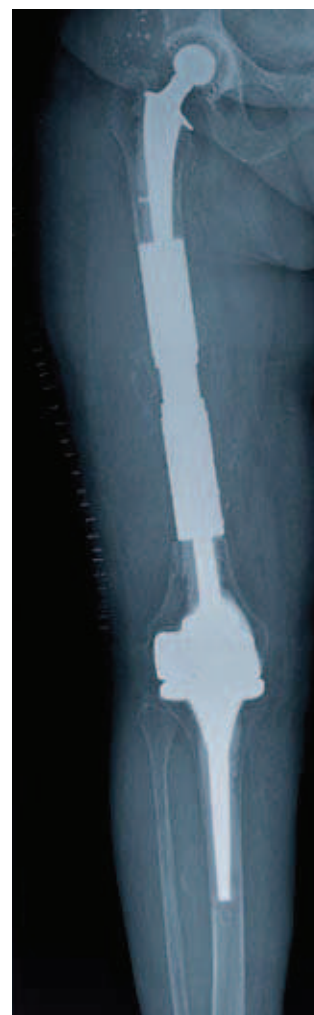
Right: **Postoperative:** diaphyseal partial replacement with sleeve coupling for hip and knee stem in situ

During the operation, Dr. Karl Schmoranzner exposed 80 mm of each of the in-situ shaft ends. The sleeve components were filled with cement and slid into place. The fixation screws were then tightened in the still pasty cement. This allowed the in-situ shafts to be centered in the sleeve components and to be additionally fixed. To conclude, the two sleeve components were joined together. The interposition sleeve was preferred principally because it entailed a significantly smaller intervention than the otherwise necessary total femur replacement.

In order to restore mobility to the 84-year-old patient after failed plate osteosynthesis (following femoral shaft fracture) and plate failure, LINK manufactured a customized interposition prosthesis. This made it possible to stabilize the affected limb. After geriatric treatment, the patient is independently mobile on underarm crutches.
